# A GUIDE TO ALTERATION AND RENOVATION OF A HISTORICAL TIMBER BUILDING USING TRADITIONAL METHODS AND MATERIALS

THE ORIGINAL RELEASE

2016 THE TOWN OF RAUMA

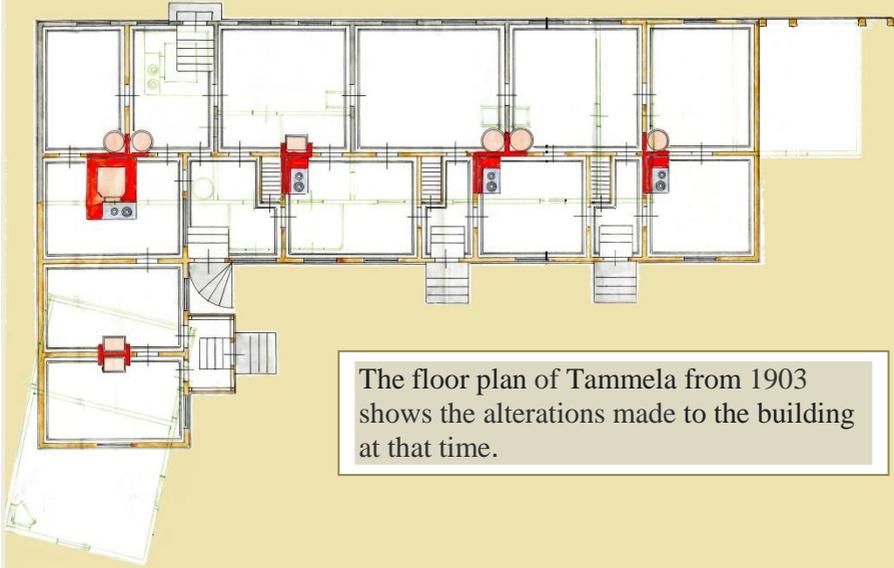
The floor plan of Tammela from 1903 shows the alterations made to the building at that time.

The oldest building permit plan is dated 1903. It was an alteration plan according to which the main building was extended on the courtyard side. At the same time a south wing was built by attaching a separate timber frame to the main building. In the alteration the length of the main building was shortened by removing one timber frame in the east end. A natural gate to the courtyard was formed.

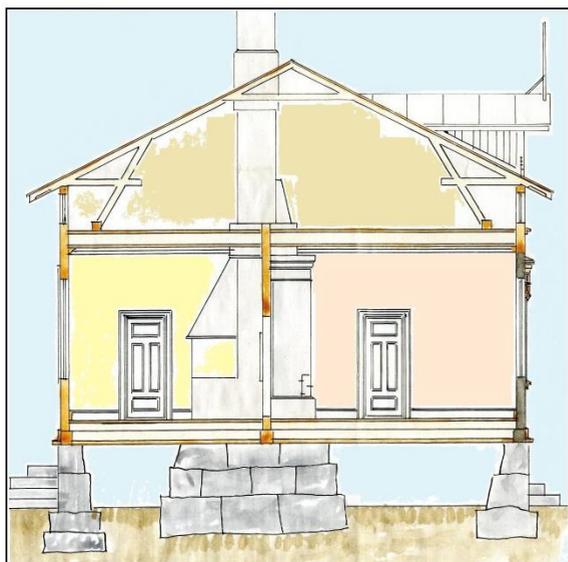
A cross section of the house of Tammela from 1903 shows the typical structures of a timber building. The foundation is made of natural stone and the timber frame rests upon it. The attic has a board structure.

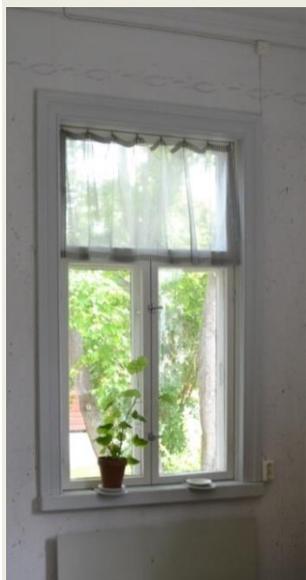
All doors have been repainted, modern rimlocks have been removed and thresholds have been reinstalled. Also the handedness of some of the doors has been changed. The joints of the window frames and the wall structure have been checked and some caulking has been added in order to prevent draught. The bottom parts of some of the external window frames have been changed and all window frames have been painted.

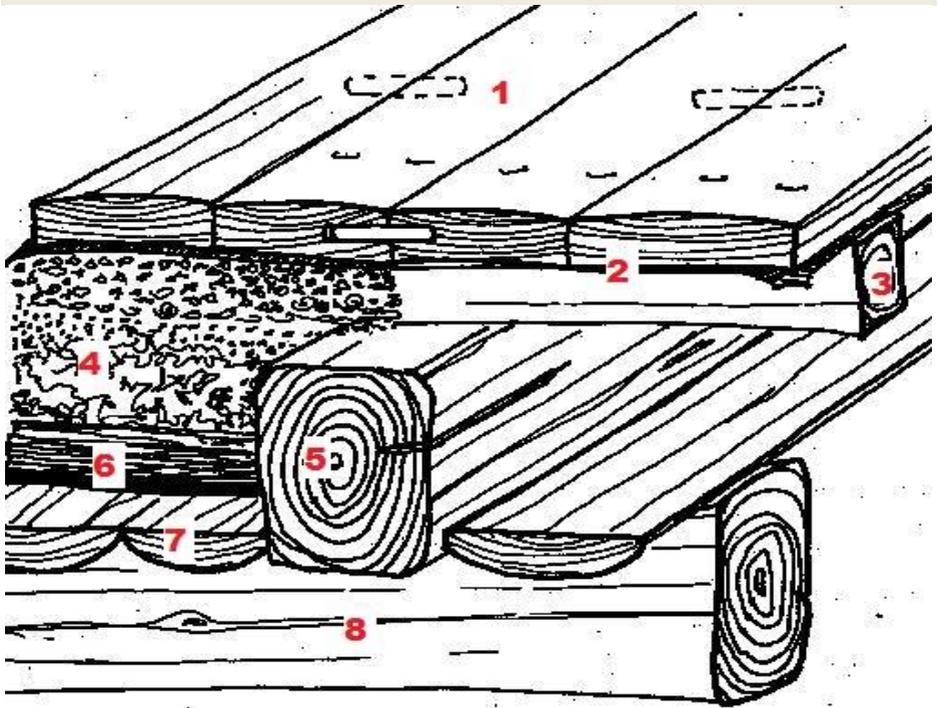
- 1.floor planks fastened with wooden dowels
- 2.building paper:tar paper
- 3.supporting rails
- 4.insulating layer:saw dust and wood shavings or pulp wool
- 5.floor supporters
- 6.old layer of insulation: moss, peat , sand and a layer of birch-bark
- 7.boards or planks
- 8.primary floor beams

A breathing base of a building is a traditional floor structure, the advantage of which is a good ventilation. When the foundation is high, as in the house of Tammela, the floor structure can be checked from below.

This kind of a base has been used in traditional Finnish floors. There is a "crawling space" between the floor and the ground, which allows the ventilation of the base of the building. Moisture as well as harmful gases rising from the ground are also aired out.

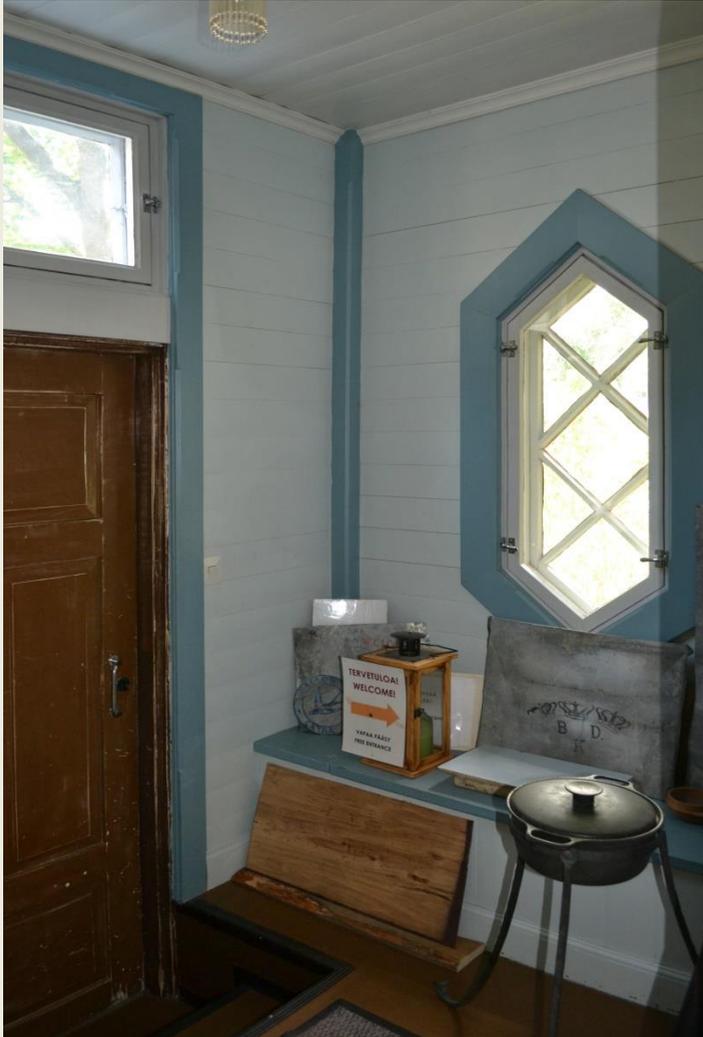
In the alteration of 1903, a separate timber frame was attached to the main building. The old timber shown above the door is the old external wall of this timber frame.

The phases of the painting process can be seen on the old panel door: the cleaning of the surface, the filling of uneven areas, a primer coat, a second coat of paint and a final coat of paint.

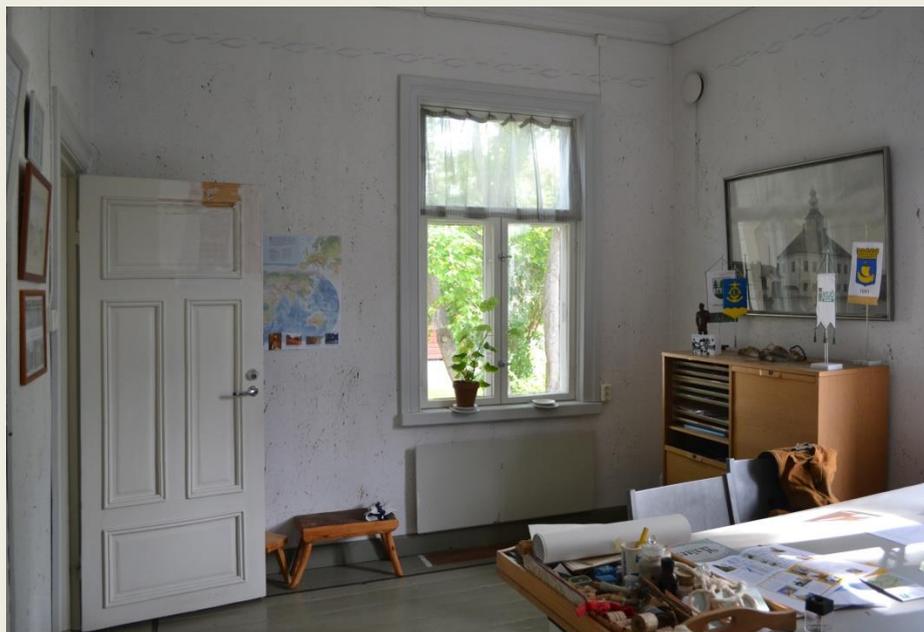
The office is the only room in the house of Tammela with the old wooden floor that has survived the alterations of the 1970s. The planks have been numbered, taken out and reinstalled after the reinforcement of the floor supporters. Saw dust has been used as additional insulation in the base of the office. In the reinstallation of the floor the planks have been fastened to each other with wooden dowels. Before painting the planks have cautiously been cleaned. The planks have been left convex on purpose. If old floor planks are smoothed their grain structure is

broken. The planks become splintery and are unpleasant to use. The paint used is lacquer paint.

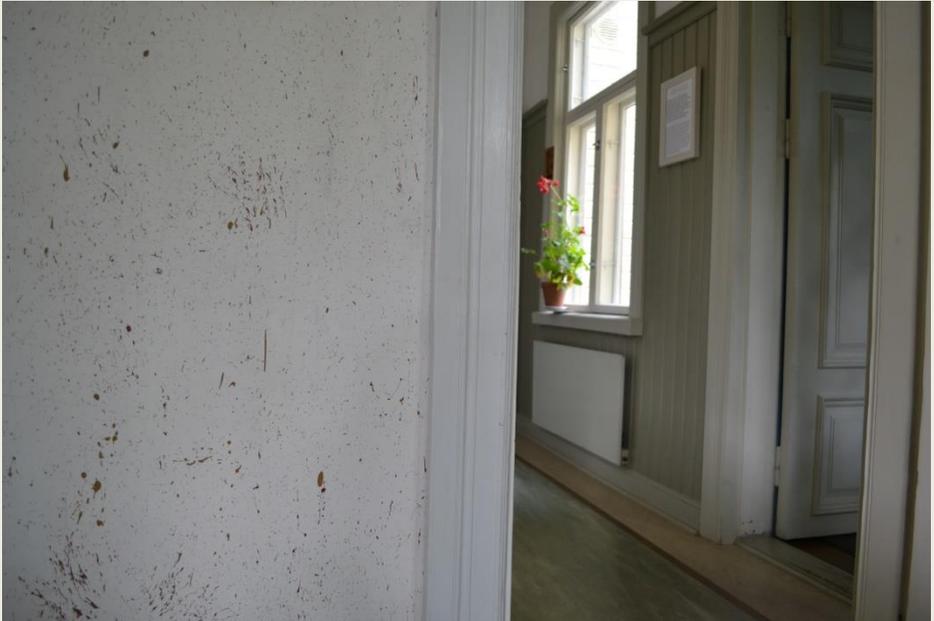
In order to disguise some of the obliquity of the ceiling, the top part of the walls has been painted with white distemper. To add decoration, a simple marine motif has been stencilled. The ceiling of the office has been covered with building board and painted with distemper.

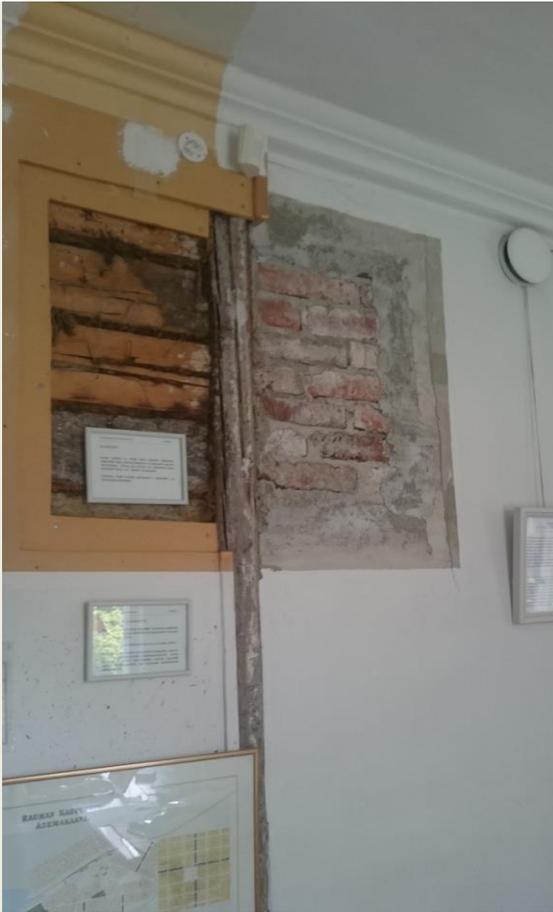
In the wall opposite the window a timber post, connecting the timber wall and the fire proof wall, has been left partly visible. The purpose of the post is to join two different structures in such a way that the timber structure can freely settle when it dries. In this case the post connects a timber wall and a brick wall, but there are also other kinds of posts. They are named after the structure to which the timber wall is connected: a door, a window or a fire proof wall.

Also displayed in this room is the additional insulation on a timber wall. Softboard is used as additional insulation, because softboard "breathes", as does the timber structure. The natural breathability of the timber structure is thereby retained.

The joint of the timber wall and the brick wall must be supported with a vertical post that stands in the groove cut to the ends of the logs. This structure allows the timber wall to settle while it dries, but it keeps the logs from twisting to the sides.

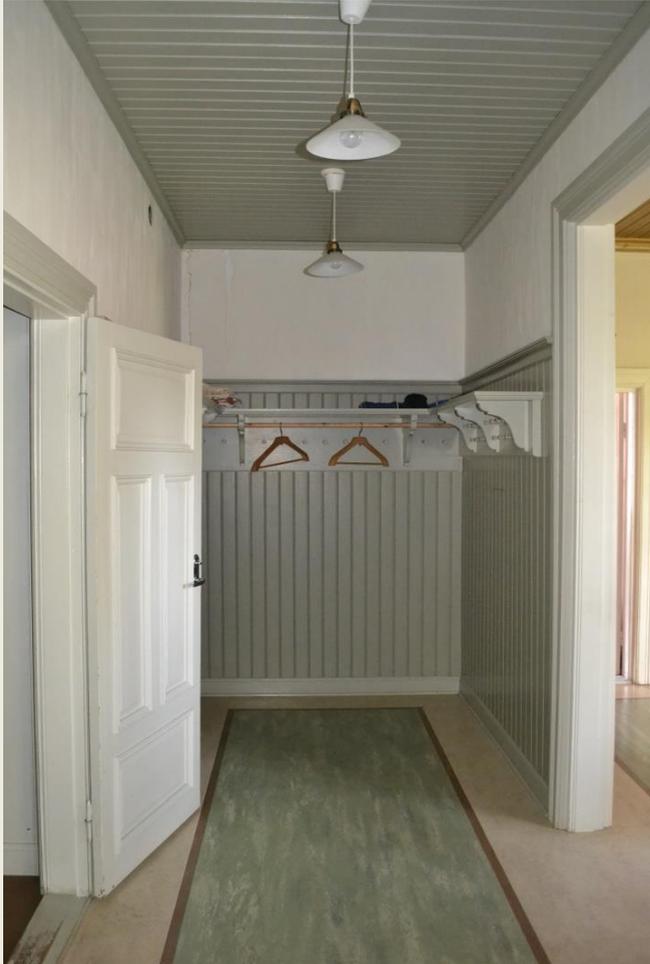
The ceiling of the hall has been clad with tongued and grooved board with a pearl profile and painted with lacquer paint. A noteworthy detail

in the hall is the coat rack which is an excellent example of skillful carpentry.

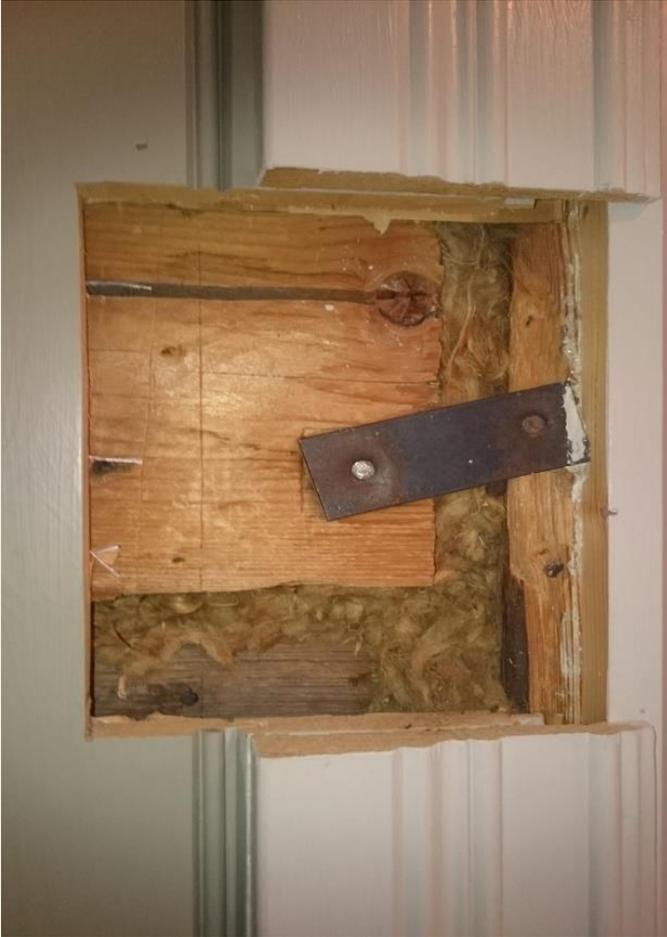
On the left hand side of the window of the hall the joint of the window frame to the timber wall has been left visible.

A flat iron is used to attach the window frame to allow the wall structure to settle while it dries.

The joint of the window/door frame and the timber wall must be flexible, because the timber wall settles as it dries. The correct way to fasten the frame to the wall is to use a flat iron which can turn as the wall settles.

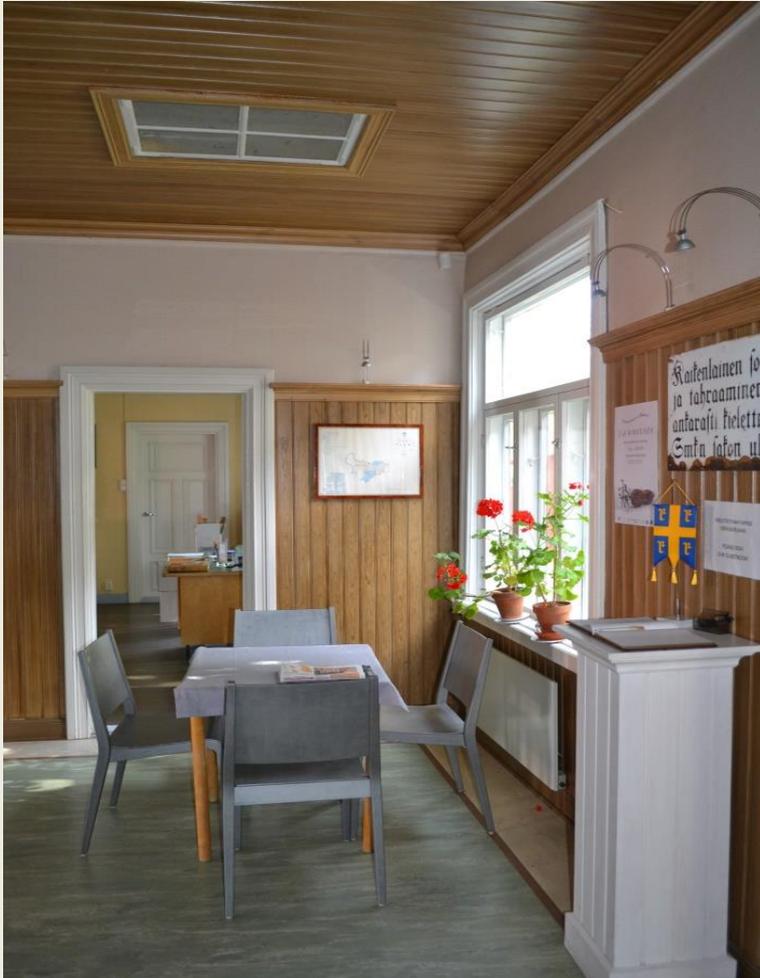
There is an opening in the ceiling of the lobby room. Through the opening the structure of an old roof truss can be seen. Also visible in the attic are the old boards beneath the roofing. They have been recycled from other old buildings and traces of red ochre can still be seen. Some of these boards are old, grooved roofing boards. On the wall between the two doors the top part of the panelling shows the different phases of the wood imitation treatment.

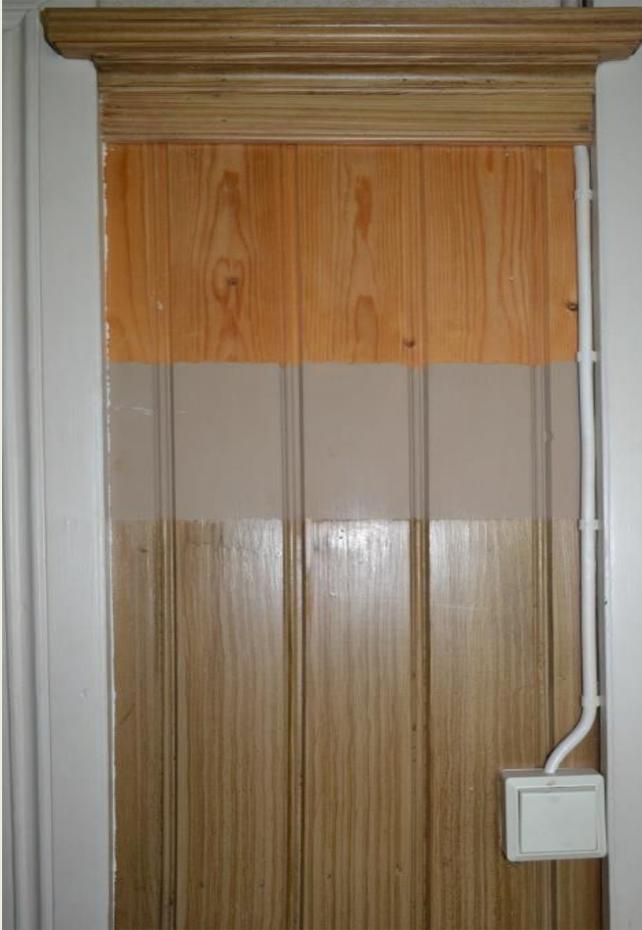
The phases for the wood imitation are: an untreated surface, a primer coat, a treatment with a fixing agent, wood imitation and finally lacquer. Root beer has been used as a fixing agent.

The wall which displays the phases of wood imitation also has a small window at the floor line. The window displays the worst enemy of a timber building, namely, dry rot. The light coloured, gauzelike layer is dry rot that has dried up. Dry rot has destroyed some of the timber structure already before the alterations of the 1970s. Dry rot destroys wood when the structure is damp and it is, therefore, extremely important to ensure sufficient ventilation in the base of the building.

The traditional, breathing base of the building enables the timber structure to stay dry. In the latest renovation the timber structure was

allowed to dry and the base of the building was replaced with a new one. Therefore, dry rot can no longer destroy the structures.

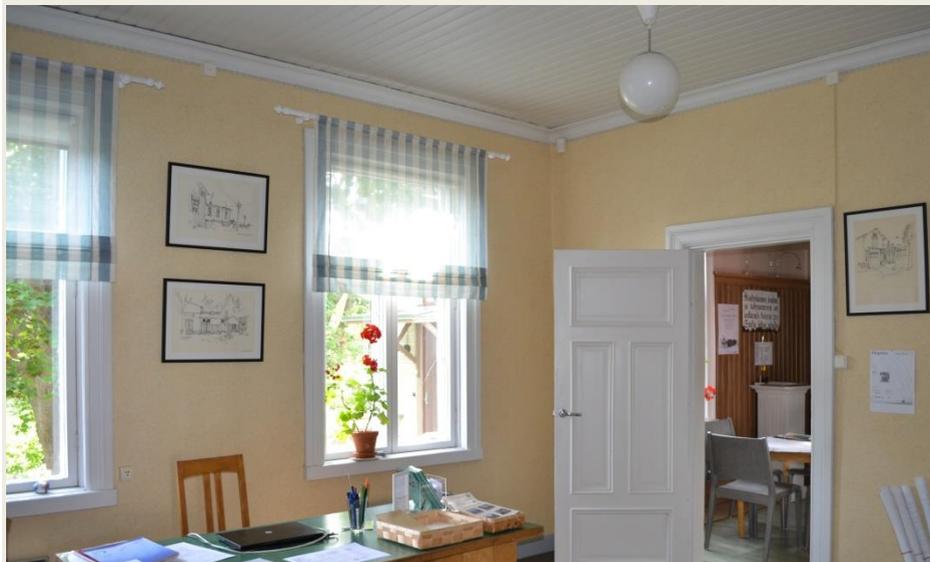
The floor of the yellow office has been replaced with a new one. The material used is tongued and grooved pine board that is 120 mm wide. The boards have been fastened with nails in the groove. The floor has been treated using grey oil glazing paint. In order to show the grains of the wood, a layer of paint with colour pigment has been applied first. This has allowed the wood to absorb the colour pigment. Protective layers without colour pigment have been applied next. In the exhibition rooms a colourless layer has been applied first, which has prevented the absorption of the colour pigment into the wood.

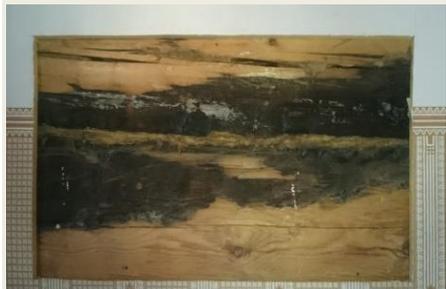
The charred timber wall tells of the fire hazard that lurked behind the furnace. In this case, fortunately, the timber wall has only been charred. Later on the wall has been partly tidied by carving.

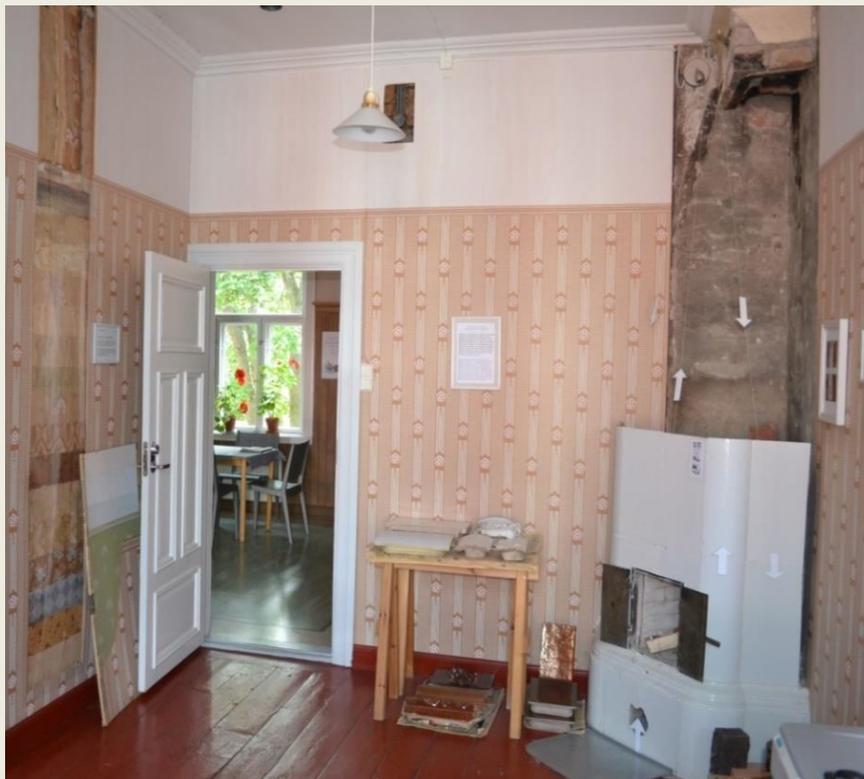
The floor planks of the room were saved from a villa that was later on incinerated. The planks have been fitted in place and fastened with wood screws. In order to disguise the screws, wooden dowels have been used. The paint used is lacquer paint.

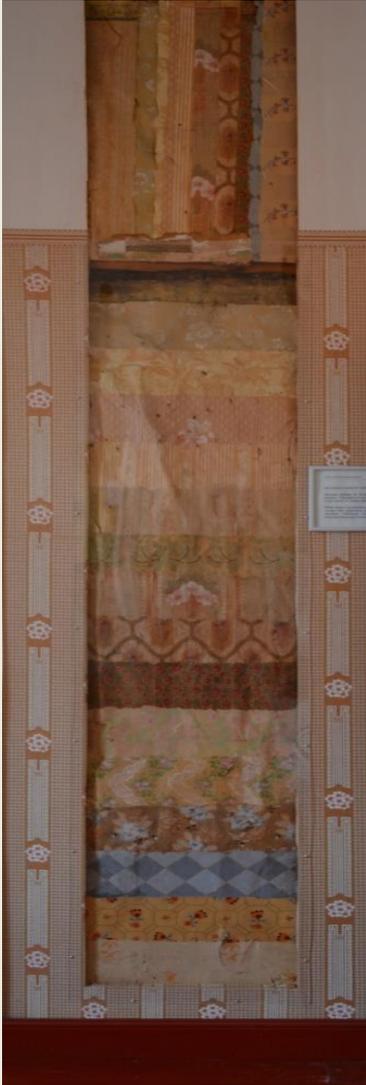
In six decades the walls have been papered 15 times, which is surely more often than in the homes of today. The frequent papering of the walls is partly explained by the fact that wood heating caused blackening of the walls. On the other hand, new tenants may have wanted to hang new wallpapers as they moved in. The pocket has been created by cautiously removing the layers of wallpaper one by one with the help of a spray bottle. The original building board is still in its place and the wallpapers have not been transferred here from elsewhere.

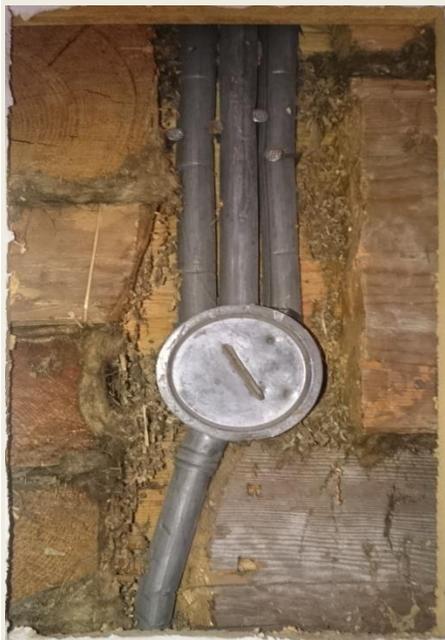
Lead-covered electronic wiring can be seen in the wall opposite the window. The wiring has been inserted in the timber wall and it represents the alteration of the 1940s.

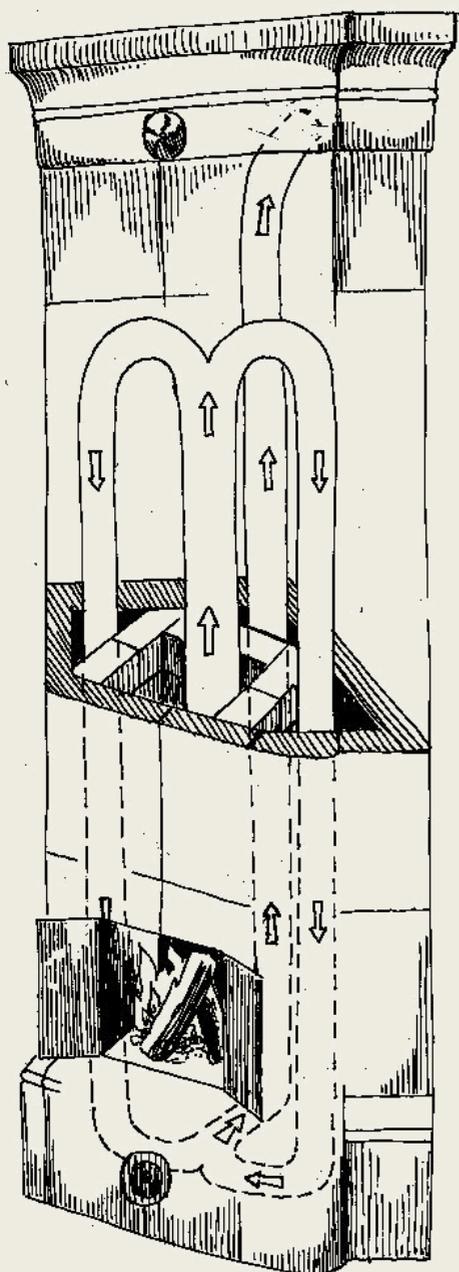
The cross section of the white stove displays the circulation system of the furnace. The combustion gas rises from the furnace and bends down along the flues on both sides of the furnace. The combustion gas then goes underneath the furnace and further to the rear where it leads up to the chimney. A tiled stove is taken apart by pouring water over it, as clay mortar dilutes in water. To be able to rebuild the stove, the tiles must be numbered. Horizontally, the tiles are marked with consecutive numbers and vertically, the courses of tiles are marked with consecutive letters, starting from the bottom course. The cross section of the stove also displays the wire tie that must be noted when taking the stove apart.

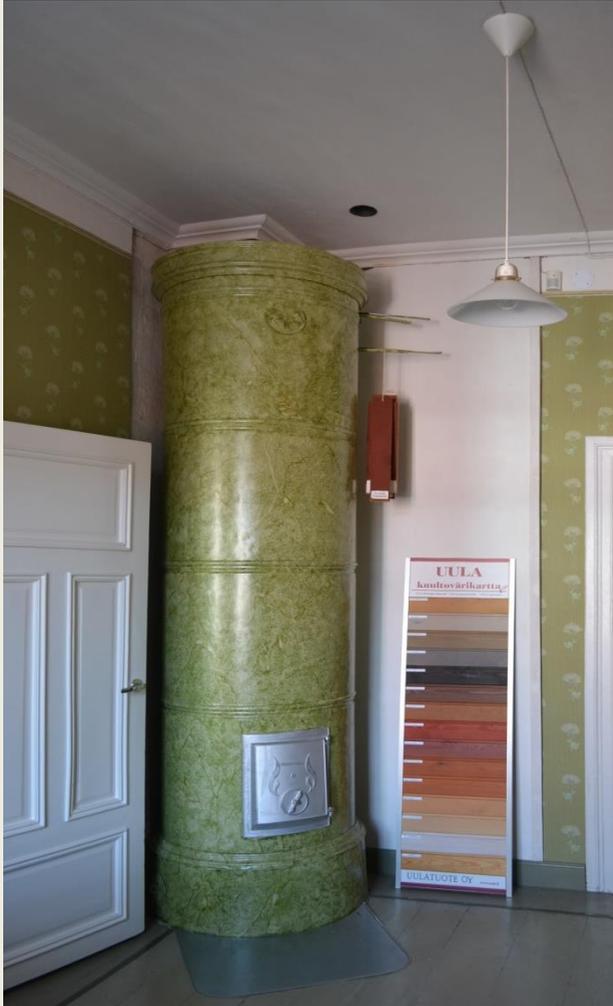
The planks have been fitted in place and fastened with wood screws. In order to disguise the screws wooden dowels have been used. The paint used is lacquer paint.

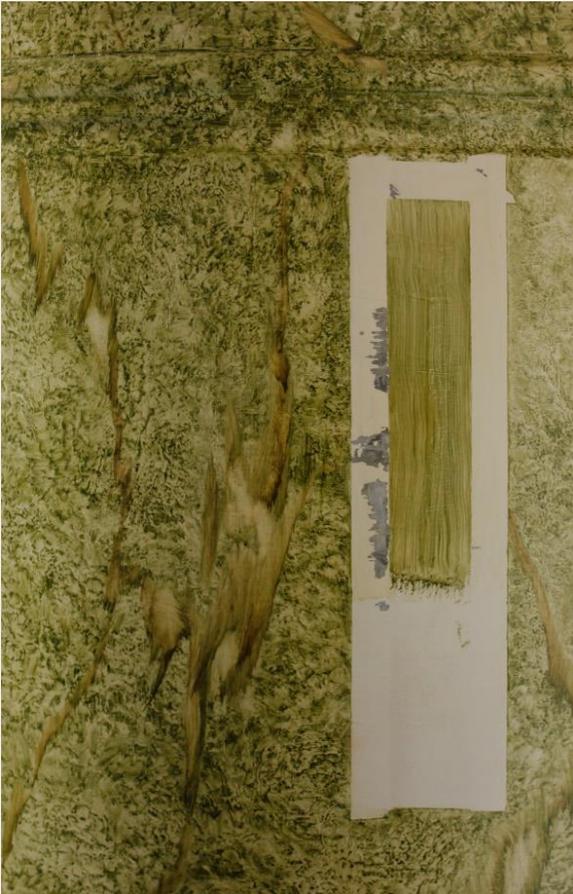
The dilapidated stove has been renewed by skilful marbling, the phases of which can be seen in a small area: a primer coat, a mixture of beer and colour pigment, treatment with a natural sponge, and finally lacquer. The marble-like image is created with a fine brush.

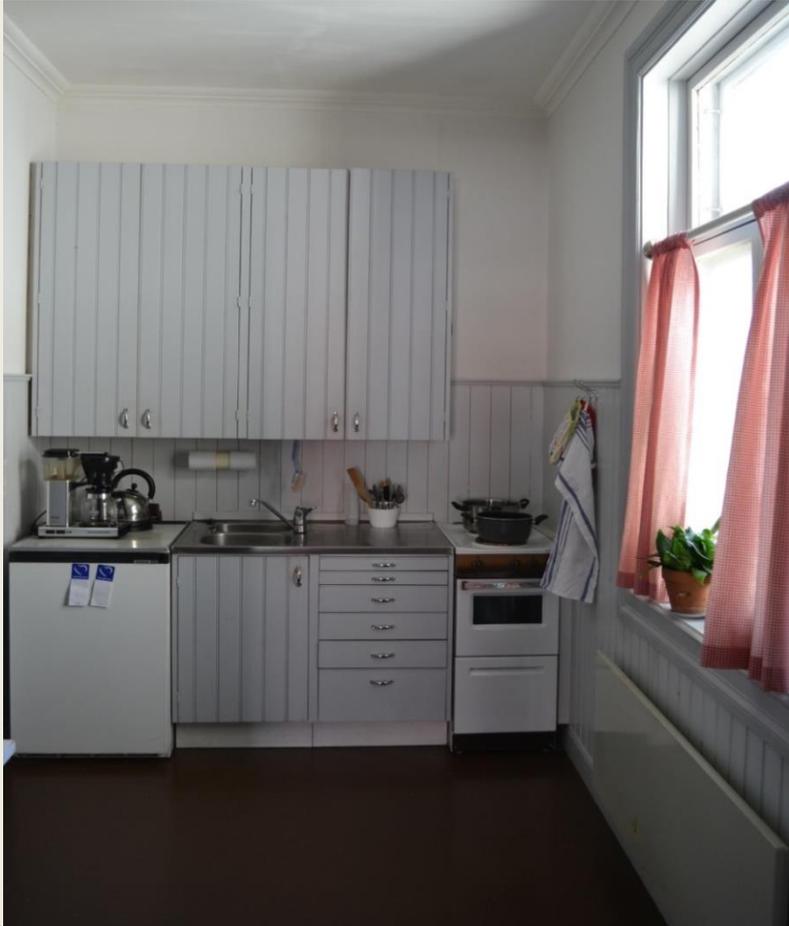
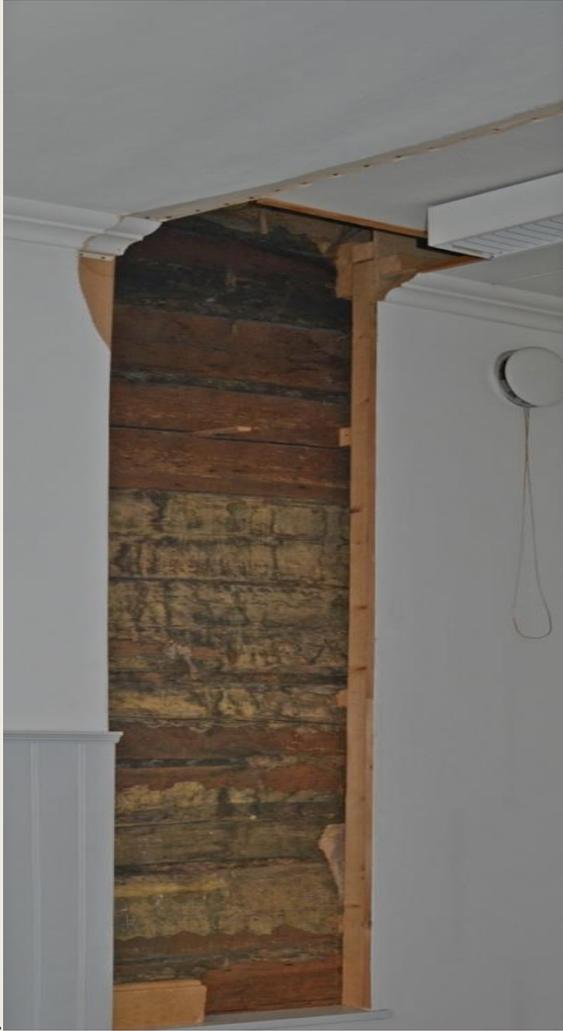
Some of the alteration of the 1970s, the era of chipboard, can still be seen in the kitchen of Tammela. Here the visitor can see the starting point of the latest renovation. The rear of the kitchen displays the typical material used in the 1970s, namely, chipboard with open joints. The colours, dark brown and white, were also typical of those times.

The use of chipboard often caused needless protective casing as the rooms were completely clad. In small rooms, such as this kitchen, a lot of useful space was lost. The suspended ceiling disguised the wiring necessary for lighting.

On the kitchen floor the dark brown vinyl floor covering of the 1970s remains. Without removing the chip board, the lower part of the wall has been clad using tongued and grooved board with a pearl profile and painted with lacquer paint. The top part of the wall has been covered with knot pulp cardboard and painted with tinted tempera.

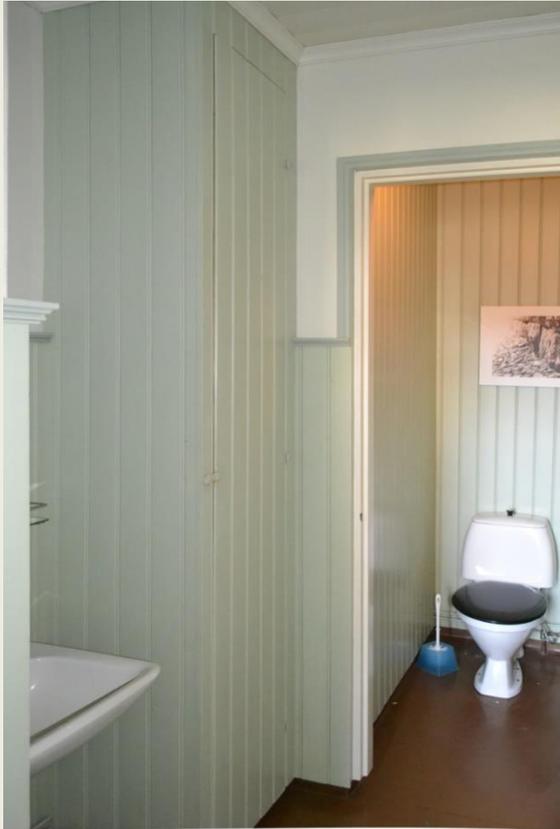
The top parts of the walls have been covered with knot pulp cardboard and painted with lacquer paint. The ceilings have been clad with tongued and grooved board and painted with lacquer paint.

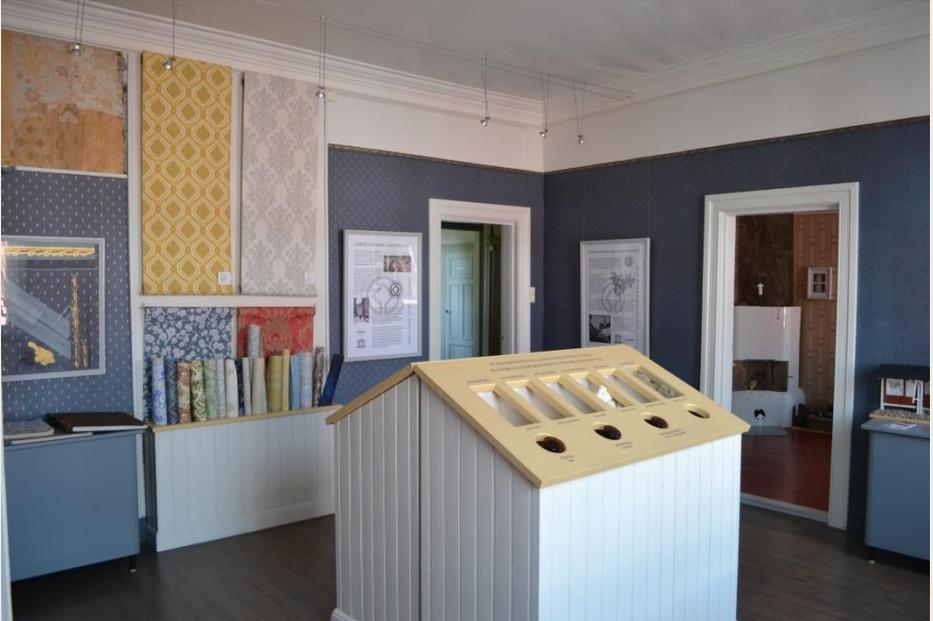
The floor of the room has been replaced with a new one in the latest renovation. The material used is tongued and grooved pine board that is 120 mm wide. The boards have been fastened with nails in the groove. The floor has been treated using grey oil glazing paint.

The walls have been primed with an inexpensive, white wallpaper and papered with an English wallpaper. The border has been especially handmade for this room. The goal was to find a wallpaper and a border that are suitable for a home of the early 20th century and, on the other hand, for an exhibition room. In this room the selection of the wallpaper was strongly influenced by the remaining old wallpaper between the windows. This wallpaper dates back to the early 20th century, as do the layers of old wallpaper on the opposite wall. Another historical detail on this wall is the old telephone wiring which has been installed as open branching over the wallpaper. The ceiling of the blue exhibition room has been covered with building board and painted with tempera. The exhibition in this room displays the UNESCO World Heritage.

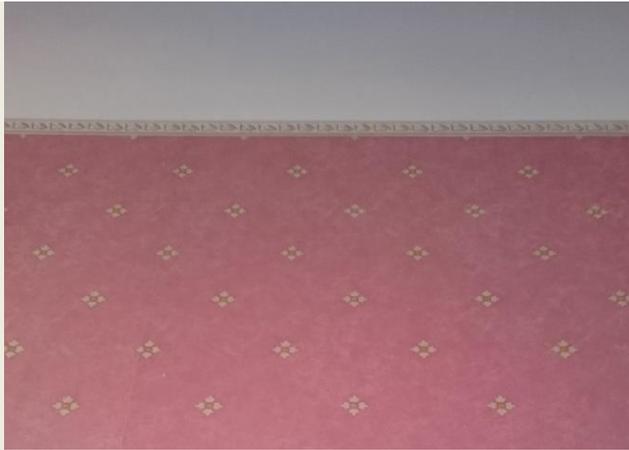
Also in this room, the floor has been replaced with a new one. The material used is tongued and grooved pine board that is 120 mm wide. The boards have been fastened with nails in the groove. The floor has been treated using grey oil glazing paint.

The walls of this exhibition room have been primed with an inexpensive, white wallpaper and papered using an English wallpaper and a Finnish-made border.

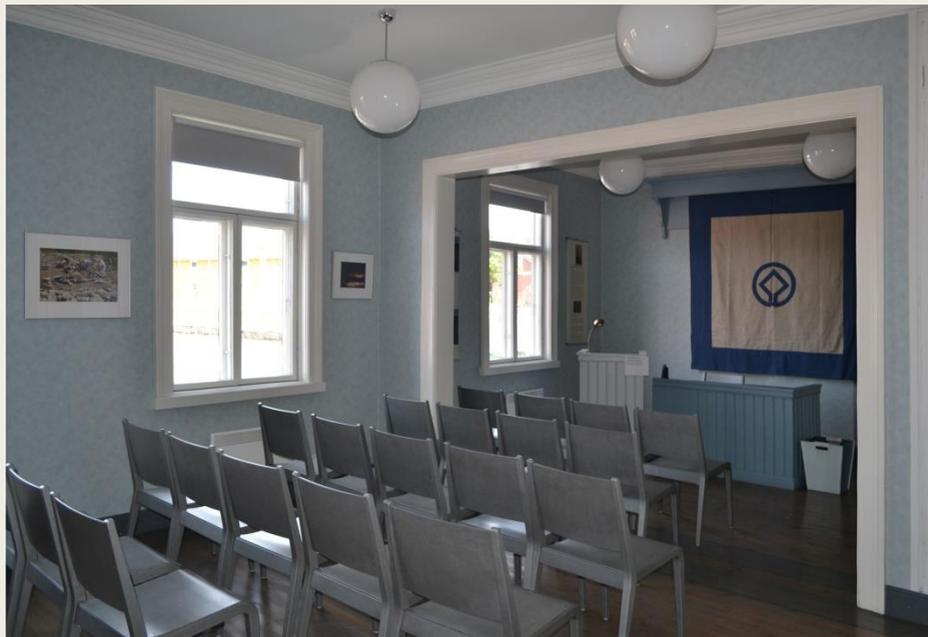
The wooden floor is decorative painted with a few different-toned oil glazing paint. The walls are covered with a blue-gray wallpaper

A historical feature on the wall is a log joint without visible log faces. As the building methods improved around the 1840s, logs were no longer joined with visible log faces. Especially in a case where an internal wall was notched in a solid wall of another room, this was a considerable improvement. The walls became much easier to paper.

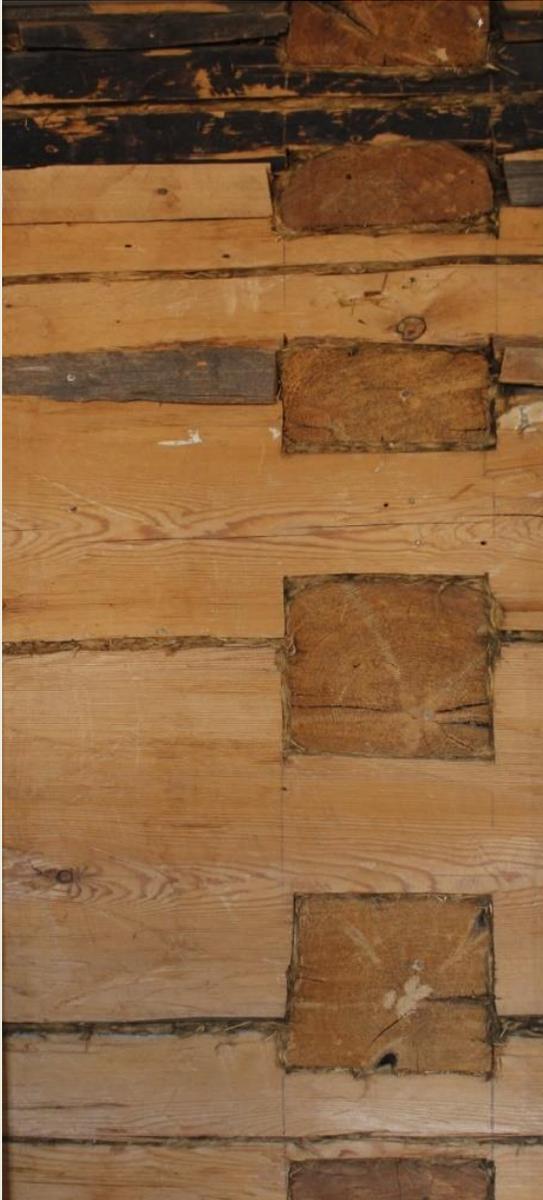
A peek hole of the log joints without visible log faces can be found in the wall of the auditorium. The visitor can touch traditional materials used for insulation and smell the scent of traditional and ecological materials used for repairs.

Traditionally a short bit of the log face has been left outside the corner joint. When the logs are joined without visible log faces the notching locks up" the corner and the logs don't exceed the corner joint. This technique became common around the 1840s.

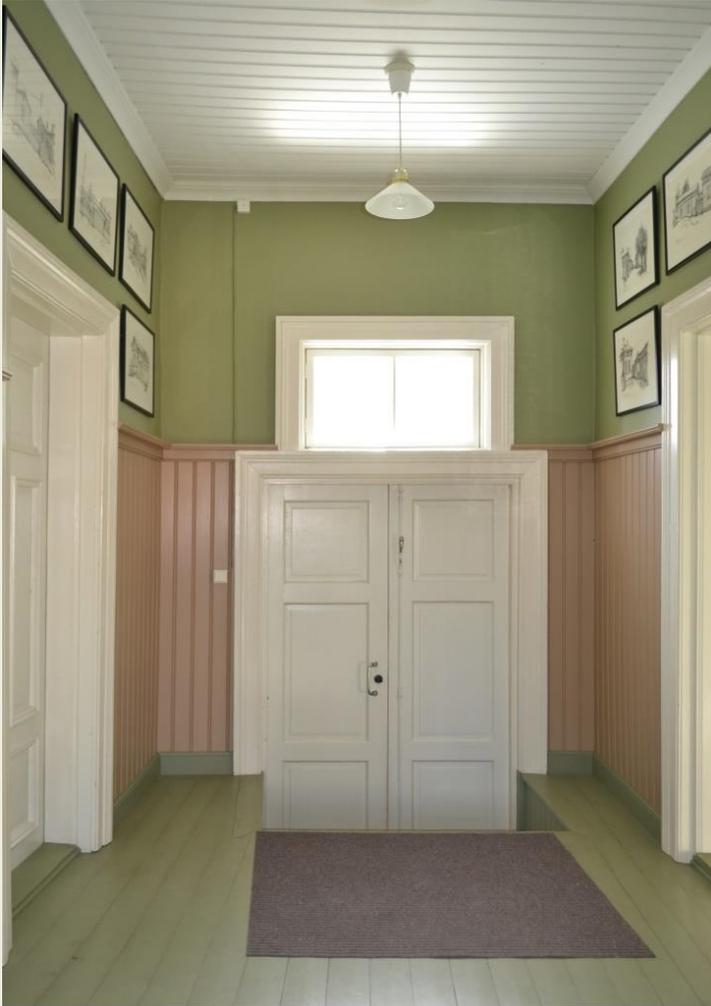
The lower parts of the walls have been clad with tongued and grooved board with a pearl profile. The upper part of the wall is covered by green wallpaper. The floor is painted with lacquer paint.

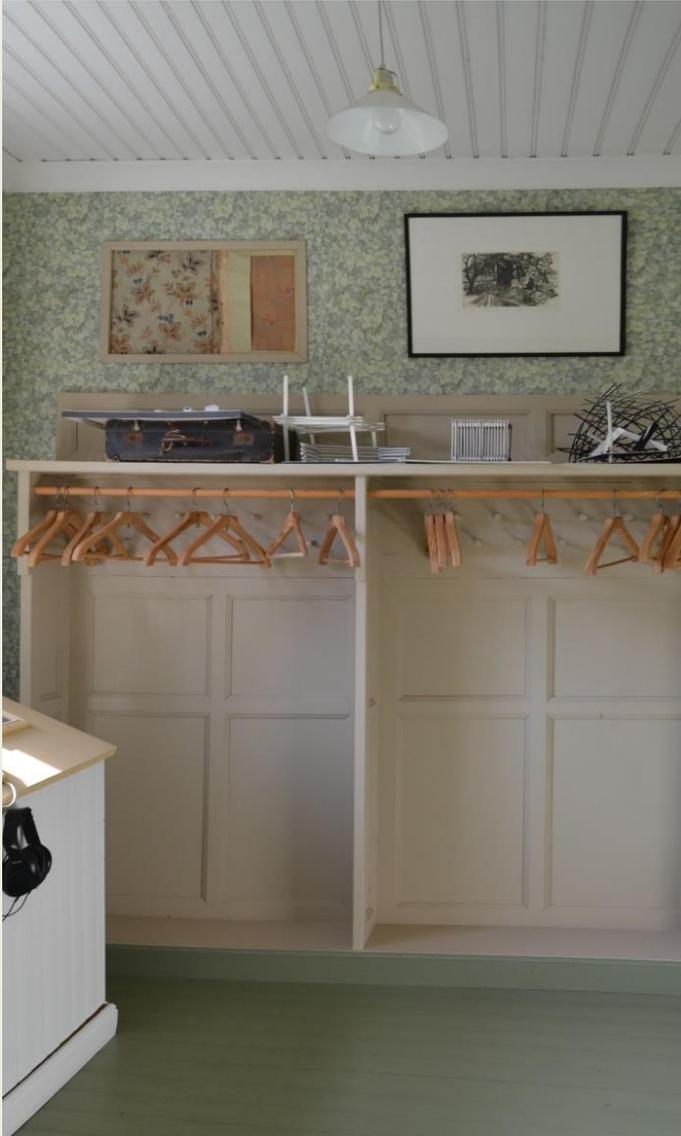
In the entrance room the walls are covered by swedish Duro wallpaper. Previous wallpaper layers are visible above the coat rack. The floor is painted with green lacquer paint.
