PRACTICAL GUIDE

Measures for heat loss prevention in historical buildings, using the experience of the Baltic and Scandinavian States

A guide for "The Measures for Thermal Loss Prevention in Historical Buildings, Based on the Experience of the Baltic and Scandinavian States"

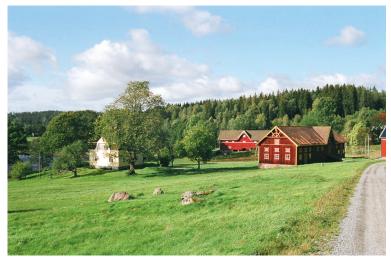
Using vegetation to shelter houses from wind is an old tradition. It is an efficient way to reduce heat loss significantly. Photo: Marie Odenbring Widmark

Identical houses in different landscapes and climates are likely to behave differently and therefore require different actions. Investigate how the building relates to its environment. How is it exposed to wind and sun? Is it sheltered by trees or hills, for example? Question the possibility to modify the microclimate around the building. Using vegetation to create shelter can actually reduce heat loss by up to 15%.

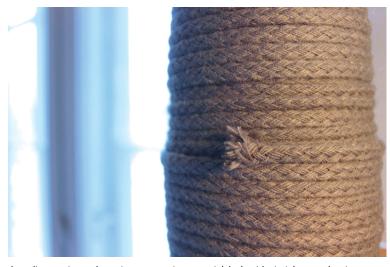
According to science, the main energy saving potential deals with air tightness when it comes to historic buildings. Sealing windows is a cheap and simple solution that will have significant effect on the energy bill. The strips comes in various materials, sizes and shapes. Cords made of wool is an example of a product that is flexible and repels water. Photo: Carina Carlsson

The strips come in various sizes and materials: rubber tubes, hemp or wool for example. When sealing double glazed windows, the strips must be mounted along the inner frames and not the external ones, in order to prevent condensation.

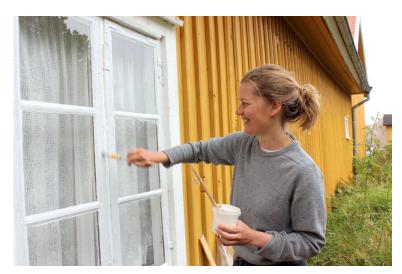
There are many reasons to save and renovate old windows instead of replacing them: economical, aesthetical and environmental, to mention some of them. With the help from a skilled craftsman, they can be improved in different ways without impact on the character. Or take a course and learn how to renovate them yourself. Photo: Ulrika Lindh

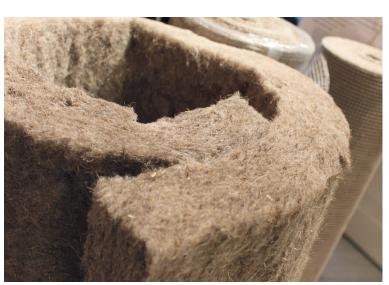
In recent years, several types of building insulation materials with low environmental impact have emerged. Insulation made of flax is one of those - a light, durable material with hygroscopic properties. Photo: Jonas Ulfsfält

Traditionally, many kinds of materials were used as insulation, differing from region to region. Materials like for example dirt or peat do not necessarily have good insulation properties and can be replaced at the time of insulation improvements, preferably with materials of a hygroscopic nature that will adapt well to fluctuating moisture levels during the year.

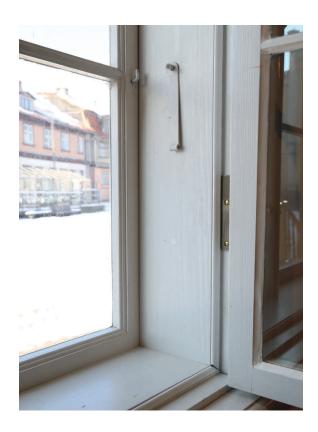
The restorable window with the applicable sealing parts in it – rubber sealing gums and the window glazing with a putty appliance in the external sashes¹²

In this building, the windows were manufactured during the process of renovation — in the second part of the 20th century — that is, in 1973, the window glasses were fixed with laths. It was cheaper, but less economical. When humidity and moisture get beyond a lath, the glass bedding rifle was damaged and through such gaps the air-flow got in.12

restore the external window sashes (manufactured in 1973) with a caulked window but produce new internal window sashes by introducing an innovation — to use a reflective glazing, which was not possible historically. It is discussed in more details in Chapter 7.3. The second place where the cold air-flow could come into the building, are gaps between the window sashes and their frames, and in order to prevent this – there were gaskets moulded (a rubber sealing contour) in the window sashes — cushion rubber of capron. It is possible also for inhabitants to purchase glued cushion gum rubbers for household necessities, but a more sustainable solution is to mold the gum, which is a more complicated, more expensive process though, as it must be performed by a craftsperson. For historic-type chamfered windows and box-type or lined windows, the rubber sealing contours are often embedded in the inner sash block. In order to ensure the best fixage density, it is necessary to individually evaluate the size of every rubber sealing for every window separately, to ensure that the density and compactness is enough for every window individually, not standardised and the same for all windows of the building. It is necessary to place an adequate rubber sealing cushion gum in the appropriate necessary thickness and length, with especially careful attention to corner connections, in order to prevent heat loss as much as possible. The third place where the most heat loss appears (visually observable), is the window frame fastenings in the wall, as the fibre tows were used as the only material, sealed on the surface. Traditionally before using them, the fibre tows were soaked in gypsum and then the tows gained more density. In such situation, they not only drain the moisture, but also accumulate it. Outside the wooden log house here, it was not possible to apply a plastering or wall rendering in such technique as it is done for masonry buildings the wall rendering was applied only in the interior where it is not flexible enough, which caused heat loss in this place. Probably the fibre tows should have been sealed more closely or chose modern-day materials which could be visually covered with window frame but would fulfil its function more effectively.

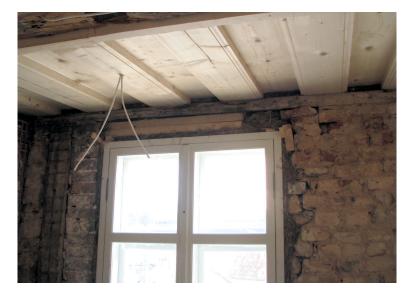
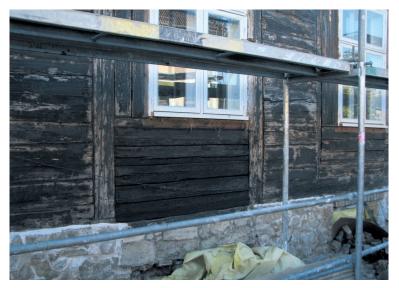
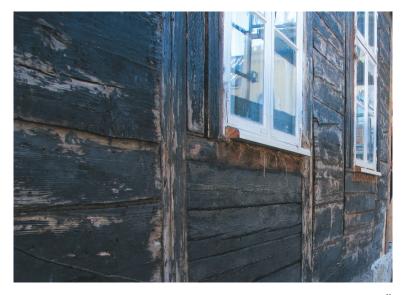
The window block application in various material walls with the supplements – flax tows¹³

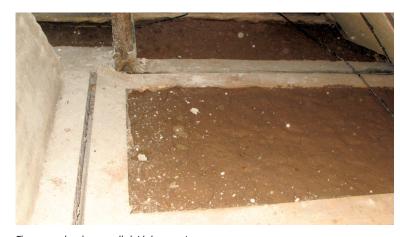
The removed and repeatedly laid clay covering

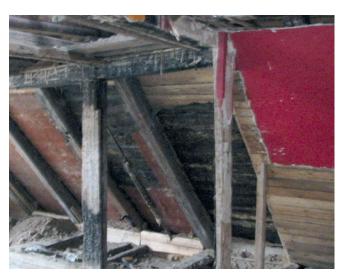
The renovation processes. The cold porches and their construction

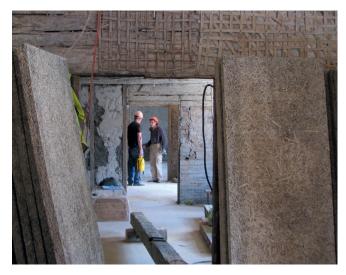
And their dismantled materials which were used in 1973 for reconstruction, including the fibrolite boards

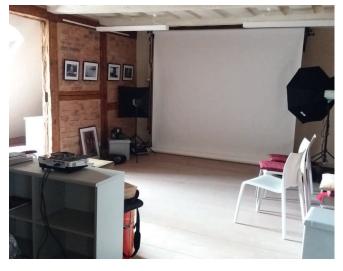
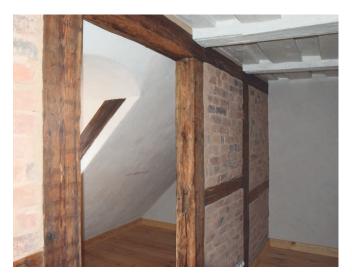
After the rebuilding renovation. The cold porches partly incorporated with the heated premises — with some openings in the filled framework walls, in order to ensure more lighting from the built-in roof parts

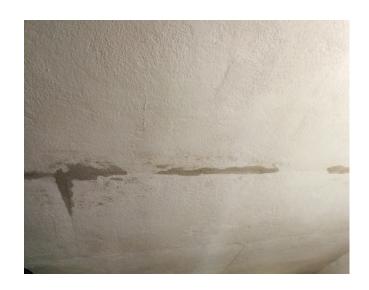
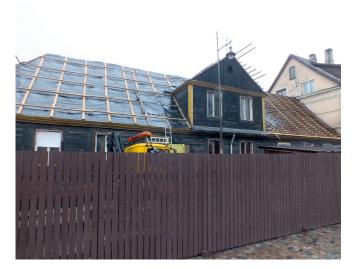
On the roof – diffusion film – under the cover – clay roof tiles

After the rebuilding renovation. There is a rendering on the fibrolite boards — as a solution which is still open for discussions, especially in a historical building where after the reconstruction the building still sinks a bit more into the ground, and there are some cracks revealed among the 19 boards, and consequently also in the rendering coverage of the wall. It is advisable to cover such interior rendering with some wood boards, where there would be no visible cracks

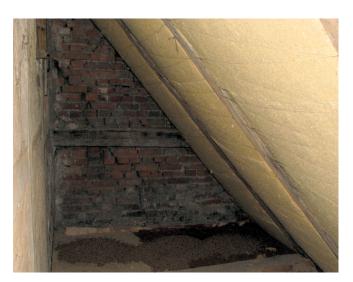
The insulation of roof board with wood fiber boards

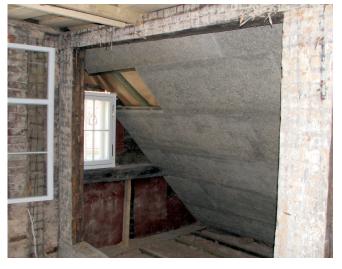
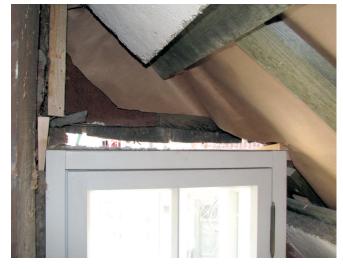
There are a steam barrier, laths and fibrolite layer placed above the wood fiber boards, afterwards the layer of the lime mortar rendering

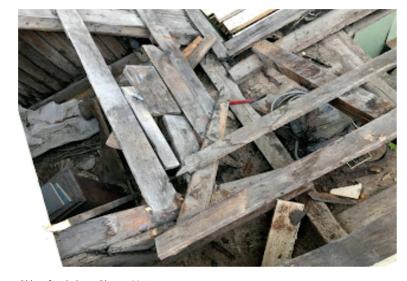
Old roof underlayer. Photos: J.Laineste

The roof covering was depreciated; the roof underlayer was partly missing. The old roof was removed and a new roof underlayer was build. The roof covering was replaced with hand-rolled zinc roof sheets. Just a couple of firms can provide hand-rolled metal roofs in South-Estonia, often pre-rolled sheets are used. At the Vambola street house historically the roof had been hand-rolled and the new one was made the same way. To prolong the life-cycle of the roof the metal sheets will be painted with linseed oil paint in a few years (after the zinc layer has abrased). Some of the funnels of the rainwater system were preservable, the rest were replicated.

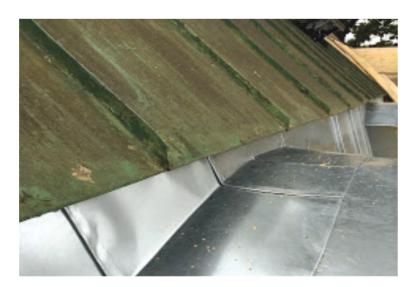
Replaced roof covering

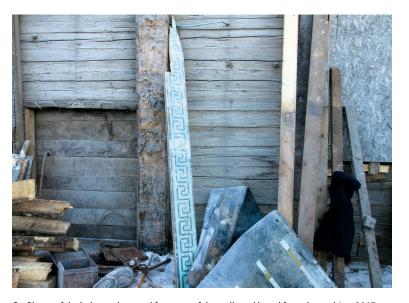
$Profile\ cut\ of\ the\ balcony,\ damaged\ fasteners\ of\ the\ walls\ and\ board\ from\ the\ vaulting\ 2017$

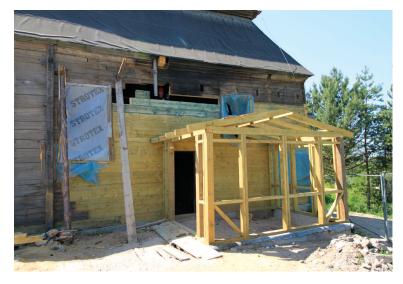
Restoration of wooden wall: implants and partial change of logs 2017 (photo M. Veliulis)

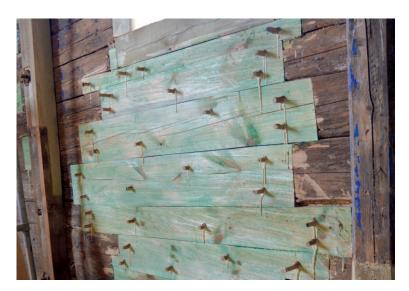
Restoration of wooden wall: implants and partial change of logs 2017 (photo M. Veliulis)

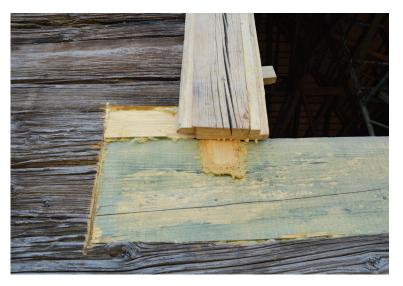
Inappropriate restoration of window frames 2017

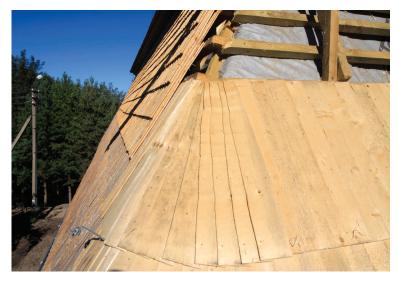
Spruce shingle roof covering 2017. (photo M. Veliulis)

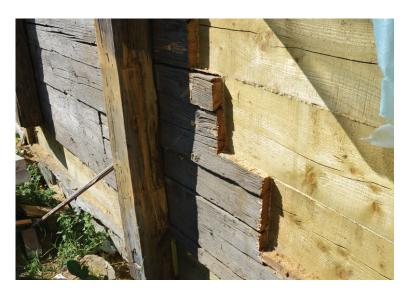
Wall insulation and boarding of the sinagogue 2017 (photo M. Veliulis)

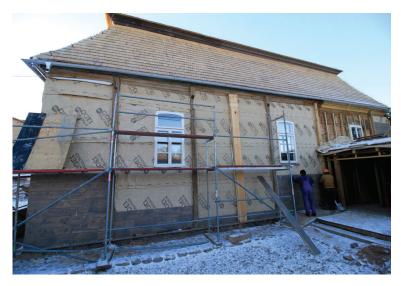
Wall insulation and boarding of the sinagogue 2017 (photo M. Veliulis)

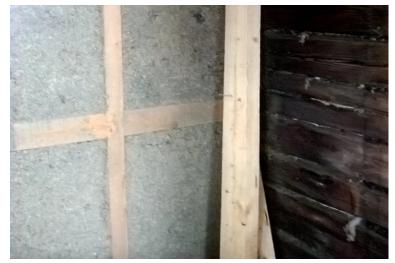
The external vestibule's framework was insulated with 150 mm of wood fiber blown directly on the frame. Photo in 2018, Hanna Elo

The ceiling insulation was thickened with around 300 mm layer wood fiber plates installed onto the existing moss layer of which the thickness varied from 200 to 300 mm. The external vestibule's framework was insulated with 150 mm of wood fiber blown directly on the frame. These half warm vestibules are an effective method in saving energy by preventing heat loss in the winter time. In the kitchen, of which the vestibule is unenclosed there is a double front door.

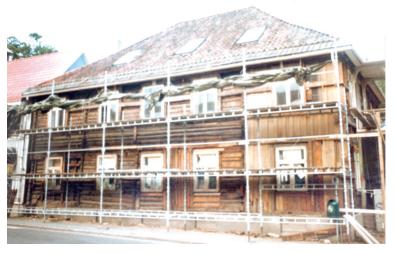
This photo was taken during the work in 1984, and we can see the main part to the left with log walls, and the frame work section to the right. A painted window on the wall in the framework section, to give balance in the facade, is visible in first floor to the right

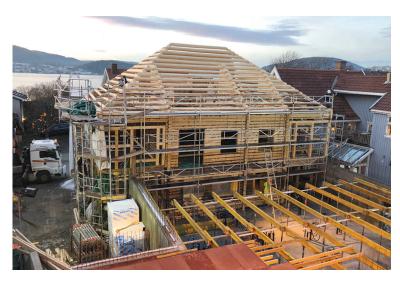
On the 5th. of December 2017 the whole building was back in town, risen up from the ash! The roof construction contains of 850 meters of round logs. In front is the roof of the new kitchen under construction. The kitchen will be moved outside the old building

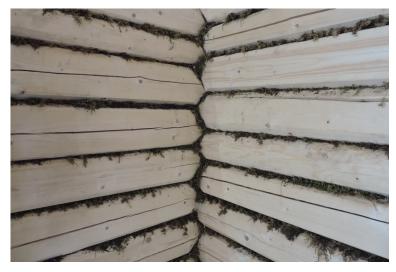
In between the logs we put wet moss (Hylocomium splendens) as tradition. This is absolutely the best material for this purpose, and is used all over Norway, Sweden and Latvia. The roof insulation will be put in a rafter construction on top of the ceiling

In 1984 the building was insulated for the first time, outside the walls, in the attic/roof construction (new apartment), and it got new windows. It was used Rockwool mineral fibres as insulation at that time. The strategy for the heat loss prevention measures in this building, is a combination of old insulation materials and new materials. When the building was rebuilt, the main part of the original building had spruce logs in the walls with 7" thickness, and moss (Hylocomium splendens) were put in between the logs, as tradition.

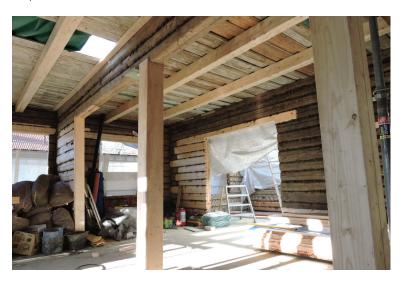
Another room in the ground floor where original ceilings is restored. The floor thickness is about 40 cm, with double crossed floor joist. Technical instalations will fit in between, and the rest will be filled up with cellulose fiber insulation
